Fire at the Urban Wildland Interface:

Performance of California Homes and Buildings

Prepared for:
California Department of Forestry and Fire Protection
Attn: Rodney Slaughter, Deputy State Fire Marshal

Prepared by:
Fire Cause Analysis
213 W. Cutting Blvd
Richmond CA 94804
Attn: Joseph Zicherman, Ph.D., SFPE.

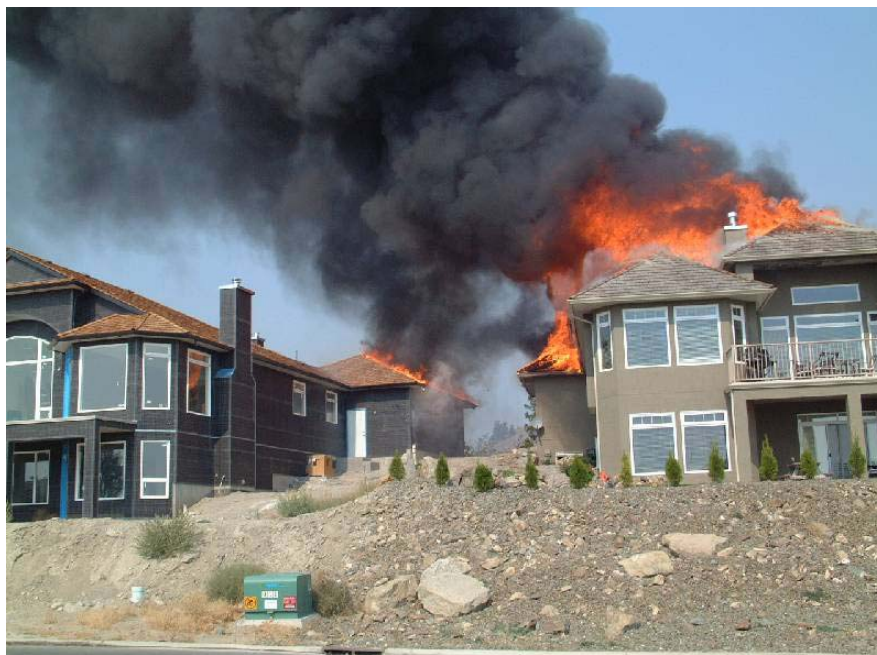
Figure18: Wood shingle roofs burning on homes in partially completed development in Okanogan, Canada. Note absence of vegetation and available defensible space. Photo courtesy of Jack Cohen.

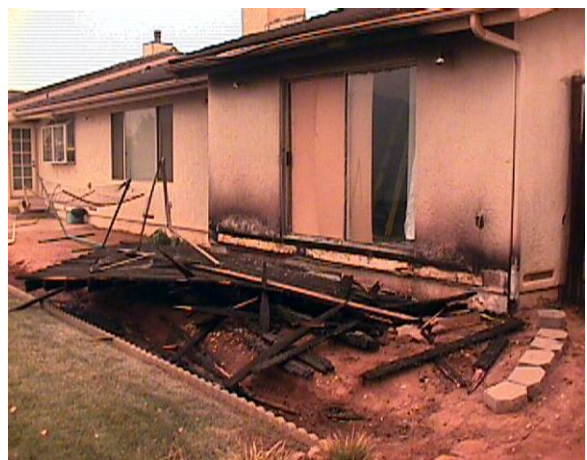
Figure 25: Stucco-sided residence in Cedar fire. Ref Cedar 1003.

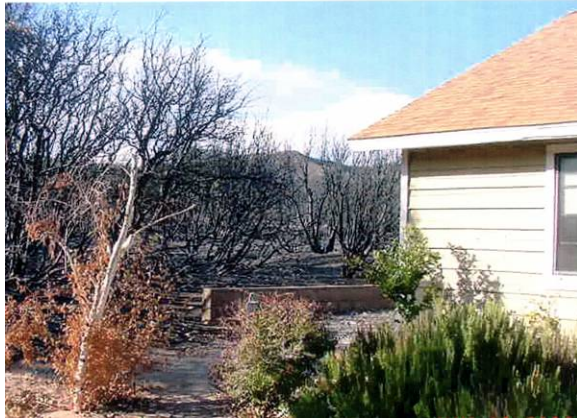
Figure 32 shows the gable end of a one-story wood clad ranch house, which facing into a growth of burning manzanita – chemise brush became charred but did not ignite. An important factor here was the defensible space between the brush and the building and the essentially complete absence of plant materials on the ground. The charred area/radiation pattern is reflective of the vertical fire plume, which had been present during the incident.

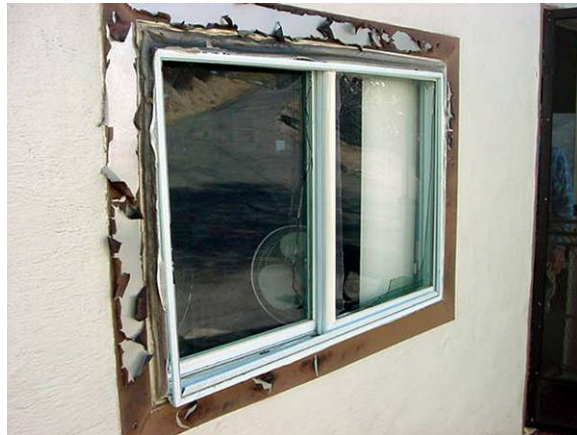
Figure 49 depicts the thermal failure of window trim without loss of the double glazed materials involved. Note the breakage of the glazing layer at the right.

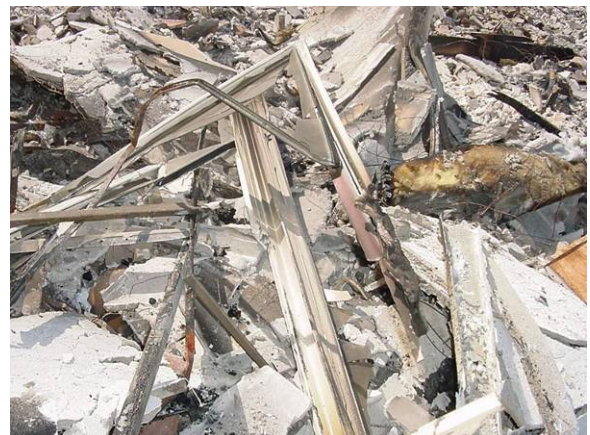
Figure 50: PVC Window and door frame after thermal failure. Photo courtesy of R. Crawford.

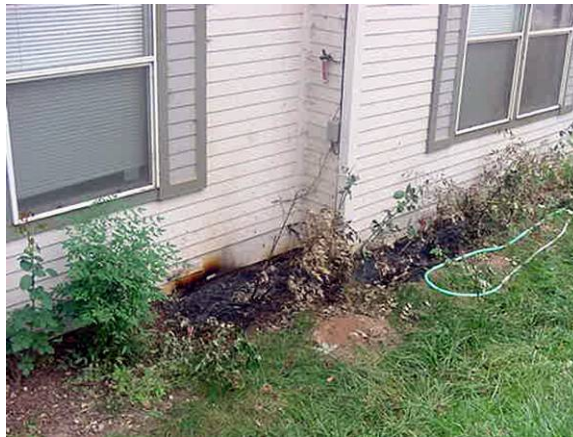
Figure 63: Area where the foundation vent was subjected to flame exposure from nearby burning organic matter. Ref Cedar 5102

Figure 1: Light combustibles adjacent to house ignited and burned to foundation vents of the house. Fire either self-extinguished or was extinguished before it could enter the home. * Cedar 5102.jpg

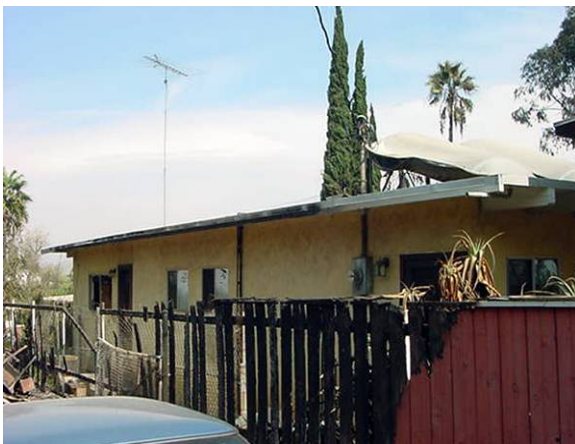
Figure 71: Depicts a wood fence, which burned and spread fire to an adjoining stucco-clad building. Ref Cedar 7050.

Figure 15: This photo depicts fire movement along fence line, causing thermal damage to the edge of the roof of an adjacent residence. Example of fencing providing easy access for fires to move from residence to residence. Reference: Cedar 7050.jpg

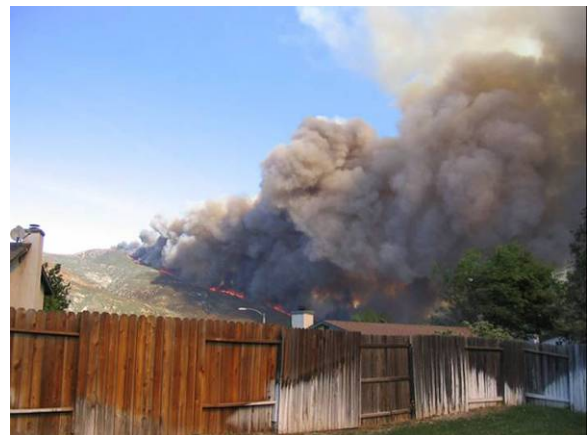
Figure 72: Involvement of wood fencing from a spreading windblown wildland fire. Photo courtesy of R. Crawford.

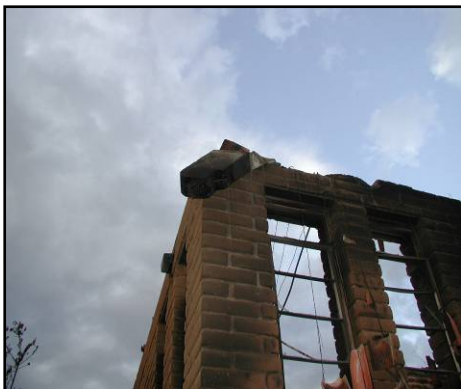
Figure 2: Fire entered structure through vents in the attic, igniting the attic space and spreading throughout the residential structure. Charring to the beams and upper section of the wall is evident. Grand Prix 34 beam.jpg

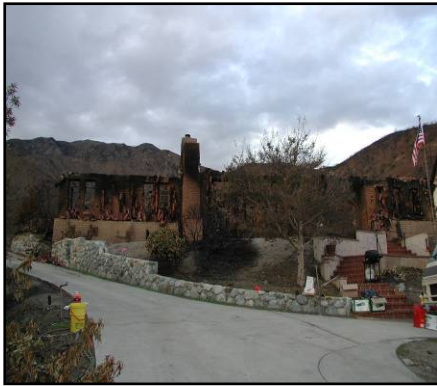
Figure3: Overall view of residence. Note remaining green shrubbery in front of the residence, which supports this loss being caused by an ember. Grand Prix 34 front.jpg

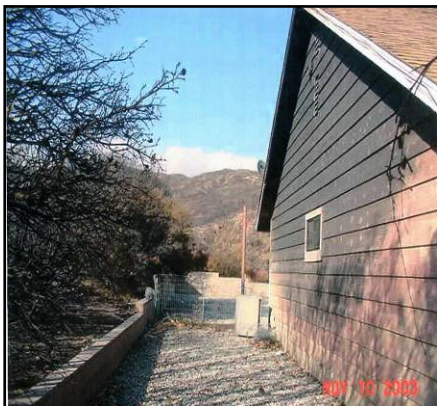
Figure 4: The fire approached the home from the side, with radiation charring the side of the home. However, no ignition occurred. Note the clearance between the vegetation and the home. Reference: Old 1 Exposure. jpg

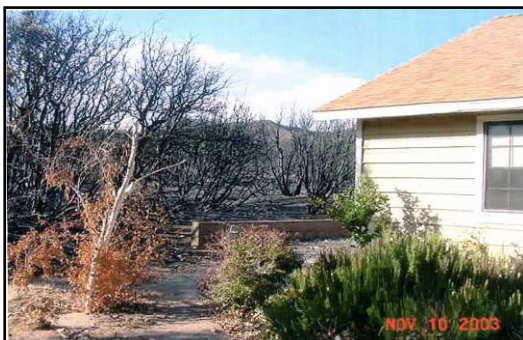
Figure 5: Adjacent side of home. Undamaged vegetation across cleared space from fire-damaged vegetation. Note lack of damage to south side of home. Reference: Old 1 Front.jpg

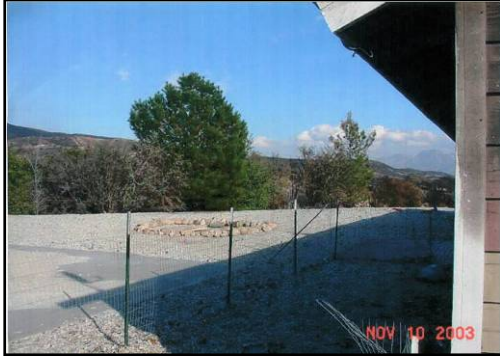
Figure 6: This photo depicts the other adjacent side of the home, where the clearance is larger than on the other side of the home. Reference: Old 1 Side.jpg

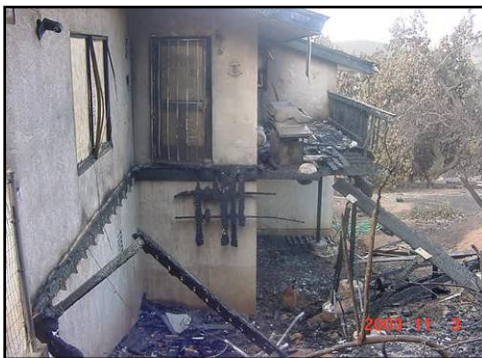
Figure 8: The fire began in the foreground of the photo, and then moved across the wood deck, which led to window breakage and ignition of the residence. This was a significant exposure. Note the burned bush near the building in the background of the photo, as compared to undamaged vegetation nearby; suggesting ignition by a brand. *Reference: Cedar 2106.jpg

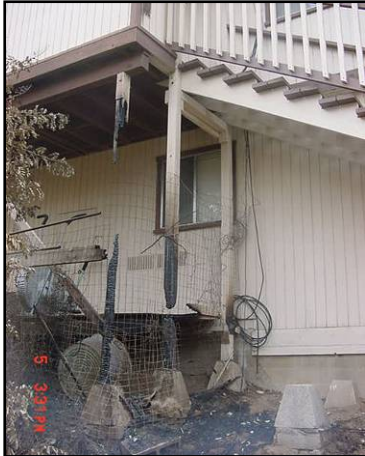
Figure 9: The fire was a ground fire that moved to the underside of the deck, then burned its way upward. Note the extensive damage to the vertical beams; this implies that the fire was burning for a while before either self-extinguishing or being extinguished. * Cedar 5101.jpg

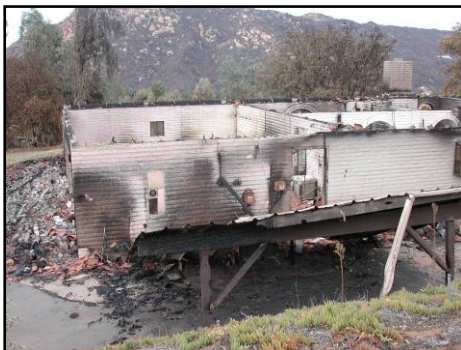
Figure 11: The fire came from a northeastern direction according to a neighbor. The fire then ignited the porch and spread across the residence. The remnants of the patio (wood posts with a tile roof) are on the left of the photo, and the carport is in the center of the photograph. Note that the charring to the carport is more severe on the left side, near the patio, suggesting fire travel from the right. Reference: Cedar 67 1124.jpg

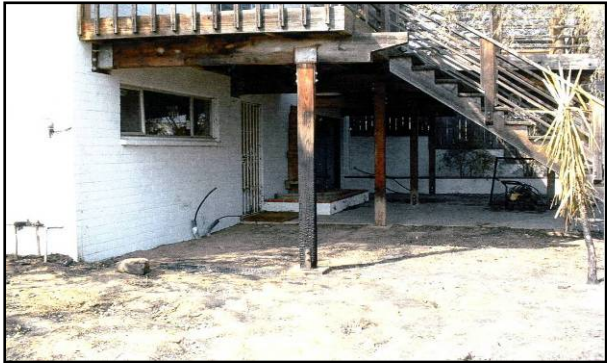
Figure 12: This fire was a ground fire, which moved along vegetation near the residence, eventually igniting the wood post of the deck. Fire either self-extinguished or was extinguished. Reference: Paradise 111.jpg

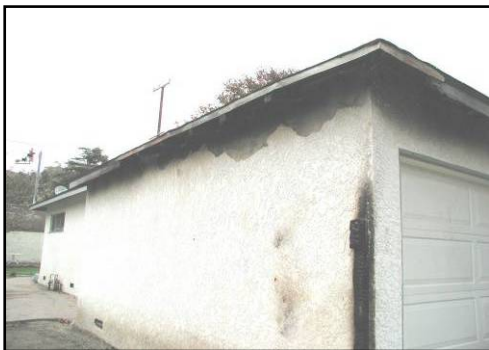
Figure 13: Fire travel under eaves. Damage to the top of walls and minor damage to roof. Embers and brands coming originated at the property next door, which was completely destroyed. Reference: Old 21 27.jpg

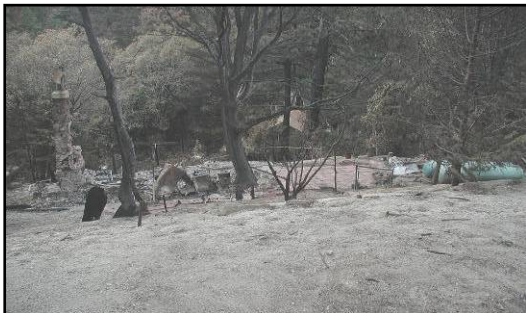
Figure 19: This photo depicts a structure that was entirely consumed by a severe fire exposure, as can be seen by the extensive damage to the trees, down to the level of the ground. This may suggest a ground fire that then moved rapidly up slope with trees igniting in a torch-like manner. Reference: Old 10 #7.jpg

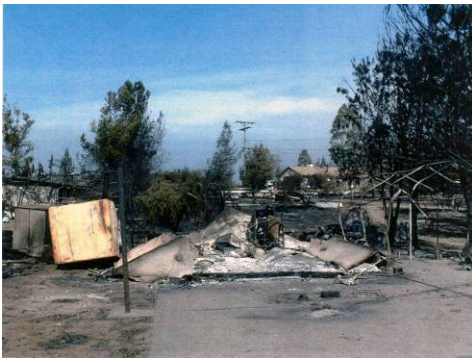
Figure 21: The fire moved from the right side of the photograph to the structure, spreading most likely by direct flame and by embers, based on the proximity of the structure to the burned trees on the right. Reference: Paradise 115.jpg

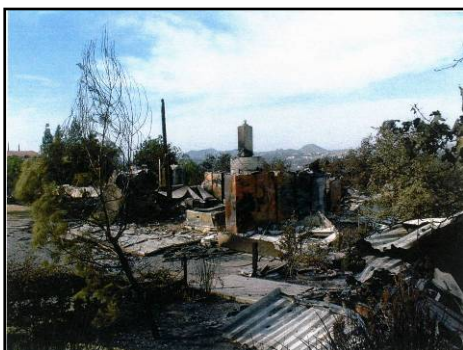
Figure 22: Based on the absence of burned vegetation in the direct vicinity of the residence, as well as the presence of an undamaged home at the left of the photograph, the damage to this residence was the result of brands or embers. Reference: Paradise 121.jpg

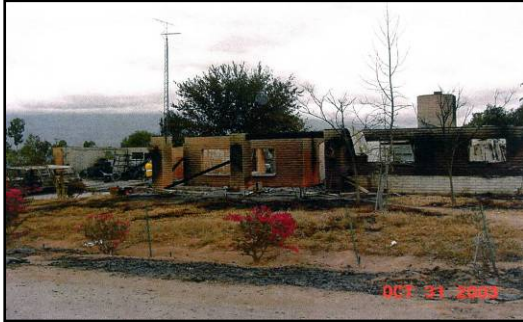
Figure 23: The dead grass in the immediate vicinity of the home, as well as several trees, provided a ready fuel bed for embers or brands. The absence of a roof to this residence suggests that embers may have become trapped in the eaves or attic space, then ignited the residence from the inside, causing roof collapse. Reference: Paradise 201.jpg

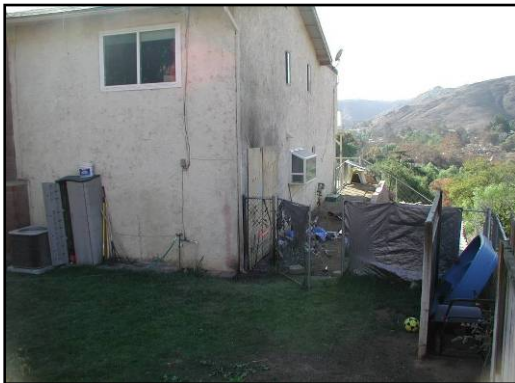
Figure 26: In this photo, sooting from hot gases exiting the sliding door is apparent above the boards currently sealing the residence. The abundance of healthy grass in the foreground of the photo suggests that the fire was not ground-based, but rather brand- or ember-based, followed by structural failure of the window.
Reference: Cedar 108 pix 162.jpg

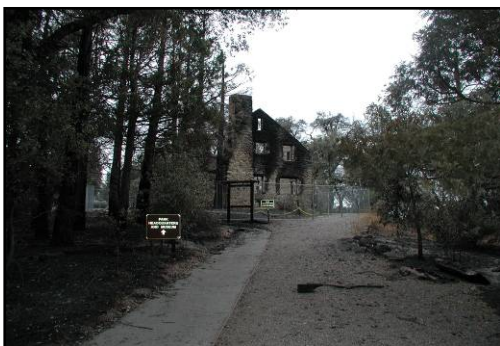
Figure 31: This photograph depicts the Cuyamaca Park headquarters and museum. There is heavy damage to the front of the building, and no roof left. Note the proximity of the vegetation to the structure.
Reference: Cedar 105 pix 117.jpg

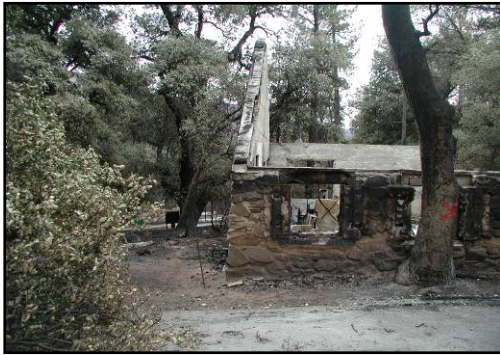
Figure 32: The wood shake roof to the Cuyamaca Park headquarters and museum was completely consumed in the fire, as can be seen in the photograph. It is interesting to note that the surrounding vegetation is relatively undamaged, with the exception of scorch marks on the trunk of the tree in the foreground where gases were venting out of the adjacent window. Reference: Cedar 105 pix 120.jpg

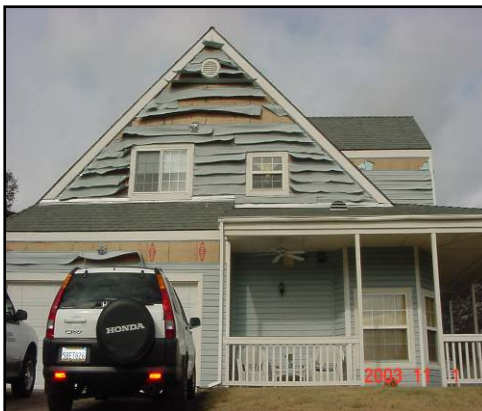
Figure 34: This home did not ignite, but convective and radiant heating by the fire front occurred. This caused the warping of the siding on the exterior cladding. Reference: Cedar 15002.jpg

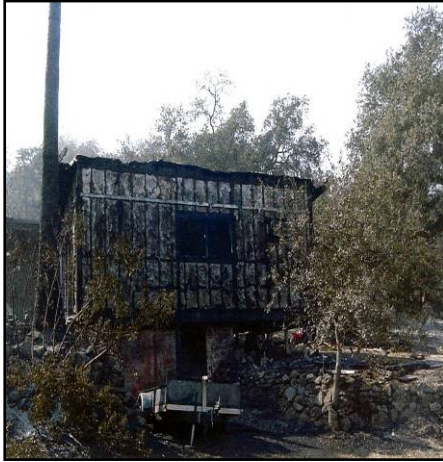
Figure 38: This structure suffered severe damage to the exterior, but it does not appear to have spread to, and destroyed the interior. Nearby vegetation is undamaged, which implies brand or ember ignition.
Reference: Paradise 416.jpg
